Isles Quarry West Borough Green

Memories of a working man
1969 - 1980

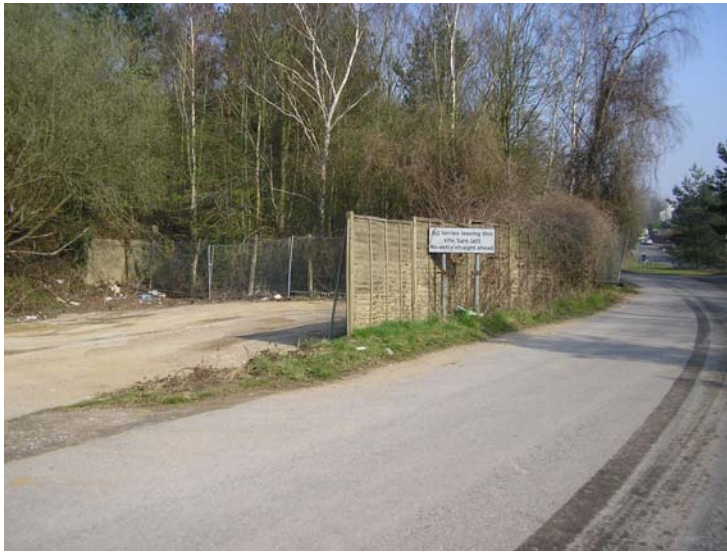
Deisel Point

The concrete wall at the centre of the left of the picture is the retaining wall that the diesel tank sat on, noted "A" on the map. This area was used for fuelling all road vehicles, and was usually awash with diesel. It was common practice for the

Tarmac tippers to spray a gallon or two out of a can around the tipper body, to prevent the next load of tarmac sticking to the body. In later years a grit was manufactured at the tarmac plant out of dust and creosote that served the same purpose, but as this did not adhere to the sides of the body, and hence allowed the tarmac to, diesel continued to be used. Much of the diesel drained to the floor during filling and overnight parking.

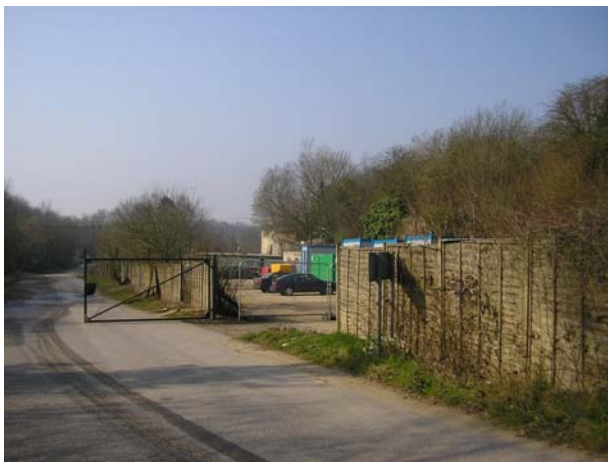
Looking south from the diesel point, "B" on the map, is the site of the filler plant, and the old tarmac plant. Both sides of this road were used for truck parking in the 60's, and would suffer from draining diesel as noted above. It must be remembered that we are talking about coaltar, not the modern bitumen extracted from oil, and there will be coaltar contamination in this vicinity.

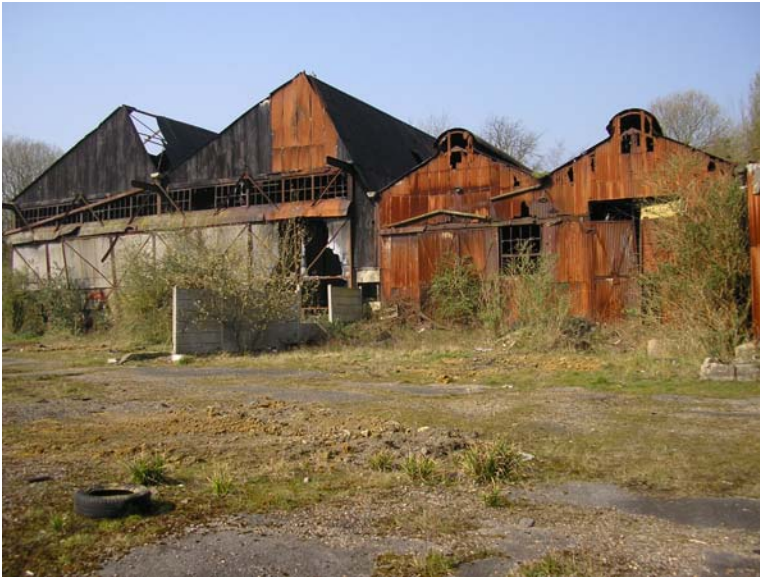
Old Service bay is on the extreme right of this picture

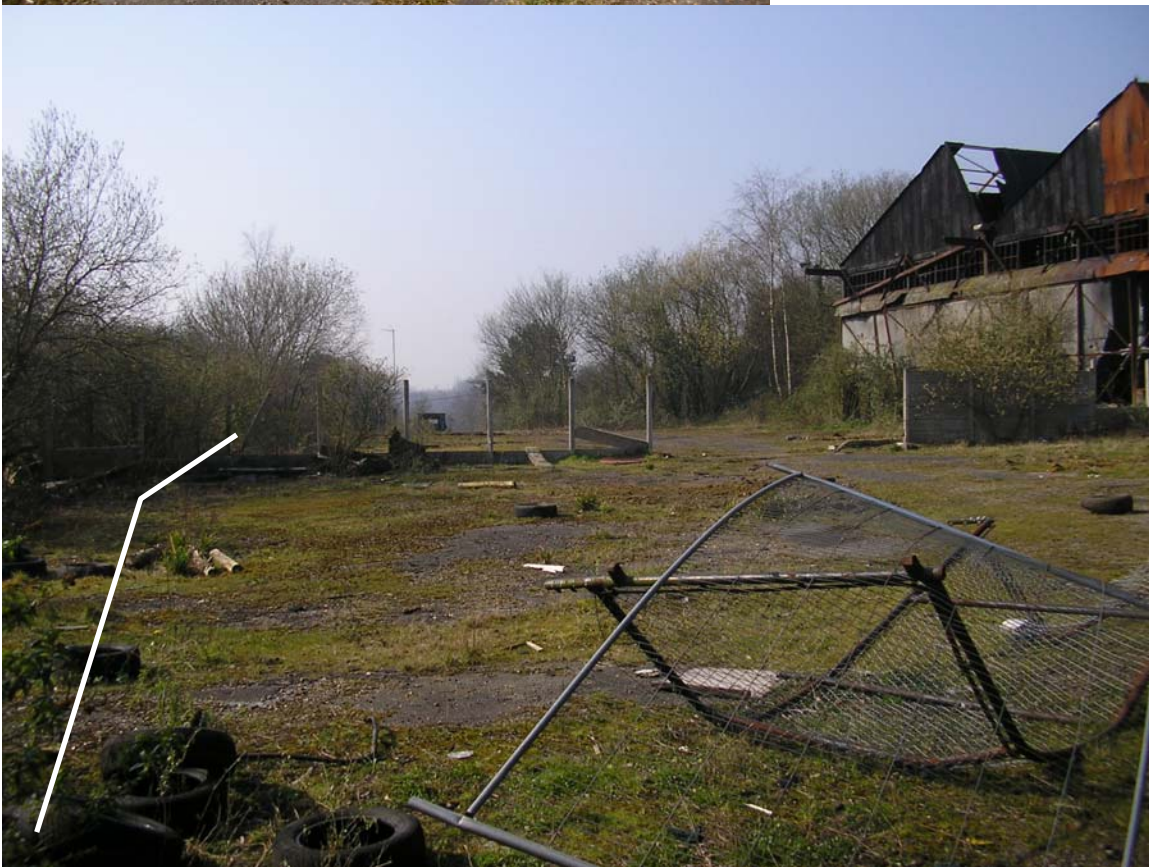
This picture is taken facing south across the old workshop yard, and the land to the left, now rough surfaced, is where we used to dump filters and burn them and the oil. The white line roughly indicates the direction of the water pipe, eventually crossing the far end of the yard and going up behind the visible buildings.

When I began work with ARC in 1969, my first job was helping an old fitter called "Tiger". Our job was the routine greasing and oil changing on all road vehicles. I have no recollection of any waste oil storage or collection arrangements, but what I clearly remember is saving all fuel and oil filters in a bucket, and as it filled during the day, I carried it across to the waste ground, together with dirty and greasy cotton waste, and every day or so, we would start a small fire and burn it. As the heap grew, we would just move along a bit.

Some time after this the water supply to the mess hut (a portable building now removed, at the south end of the workshops) failed. As a machine driver, I was asked to excavate back from the mess hut to find the break. I followed the old steel pipe across the end of the yard, and across the top of the bank edge of what is now called the high level platform, and then down alongside the road to the main tarmac road outside Isles Weighbridge. The pipe had corroded, and it was decided to replace it with blue plastic, which I believe I can still see sticking up out of the ground beside the workshop. The whole of the waste ground was a collection of old iron, old filters, bonfire residues and general waste that had accumulated over the years. In places it was almost impossible to dig because it continuously collapsed. I note ARC engineering have tidied it with a bit of rough surfacing.

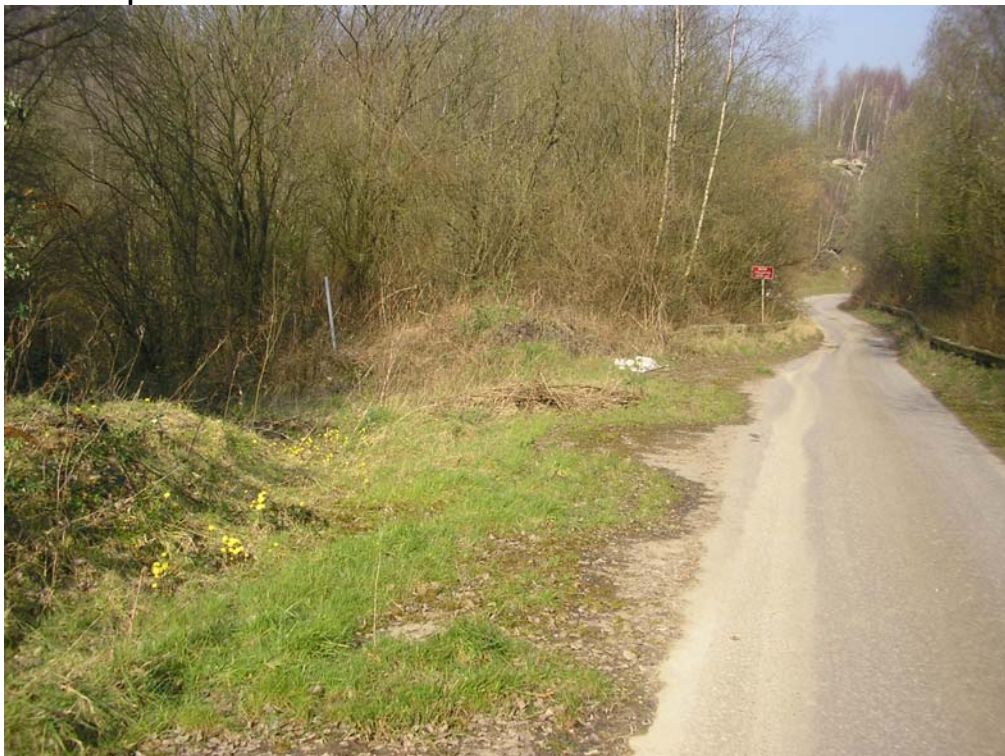
The above picture shows the draw to the left where the silted water drained to, the two pipes ran alongside this internal road, with a large drain valve in the return pipe.

The area shown as "residential allocation" on the Isles Plan attached, is an infilled lake. This lake was also used as the washout point for concrete truck mixers. The media plant in Stangate Quarry used water drawn from an artesian well that was situated roughly where the arrow is "D". This well pumped water, through a pipe of about 8" bore to the plant, and the silty return water was pumped into lagoons now marked "Public Amenity Area" to settle, the water returning via the now infilled lake to the artesians. The return water was so high in silt content that it could not be allowed to settle in the pipes when the pumps were stopped, and so the pipes were drained at the lowest point, which is the Bourne River valley, directly into the river without silt traps.

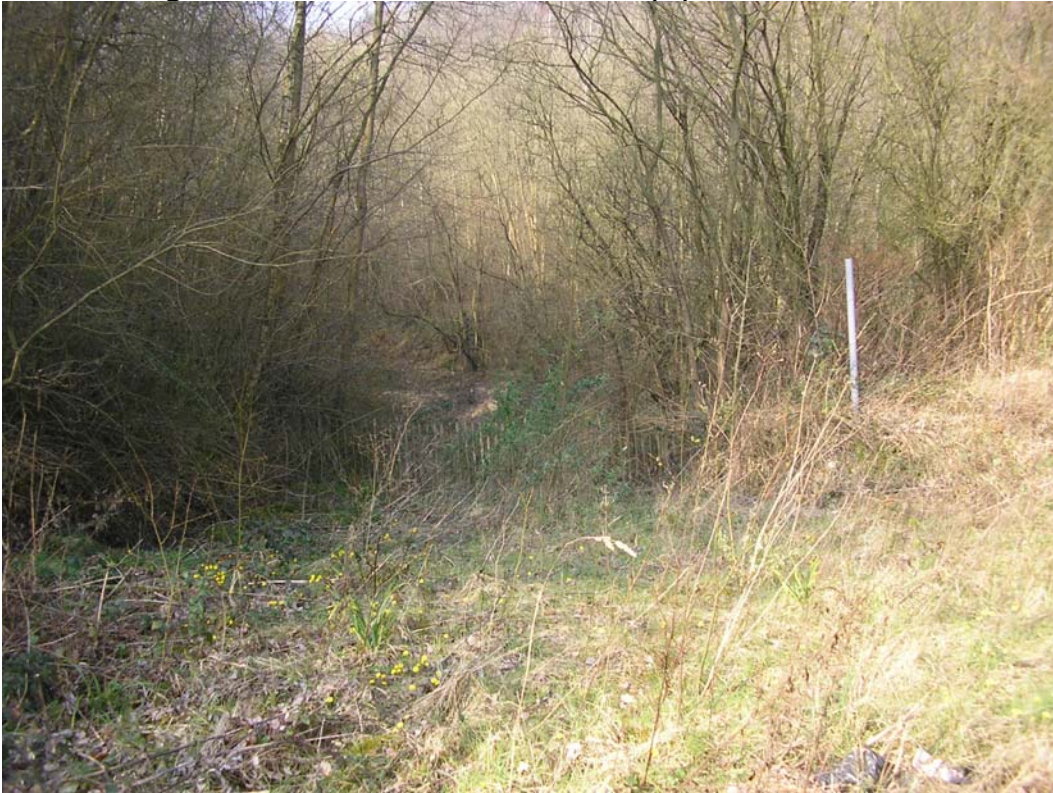
This picture show more clearly the draw running down into the Bourne, note the grey post as a comparison marker with the previous picture. It is worthy of note that the steep sides of the Bourne Valley at this point are almost exclusively quarry waste tips. The washout from these waste tips and the drainage of the washplant silt are almost certainly the cause of the drastic silting of the Mill Pond lake at Basted Mill, currently only a few inches deep, with the edges slowly turning to marsh. There is very little trace in the Bourne of Limestone Dust anymore, the source has now been washed clean. These photos were taken at "E" on the Isles plan.
