**Response to Mr Mike Taylor's Document entitled *Isles Quarry Contamination Concerns* submitted to Jennifer Wilson of the Environment Agency by email on 23.08.2014, prepared by *Geo-Environmental Investigations Ltd***

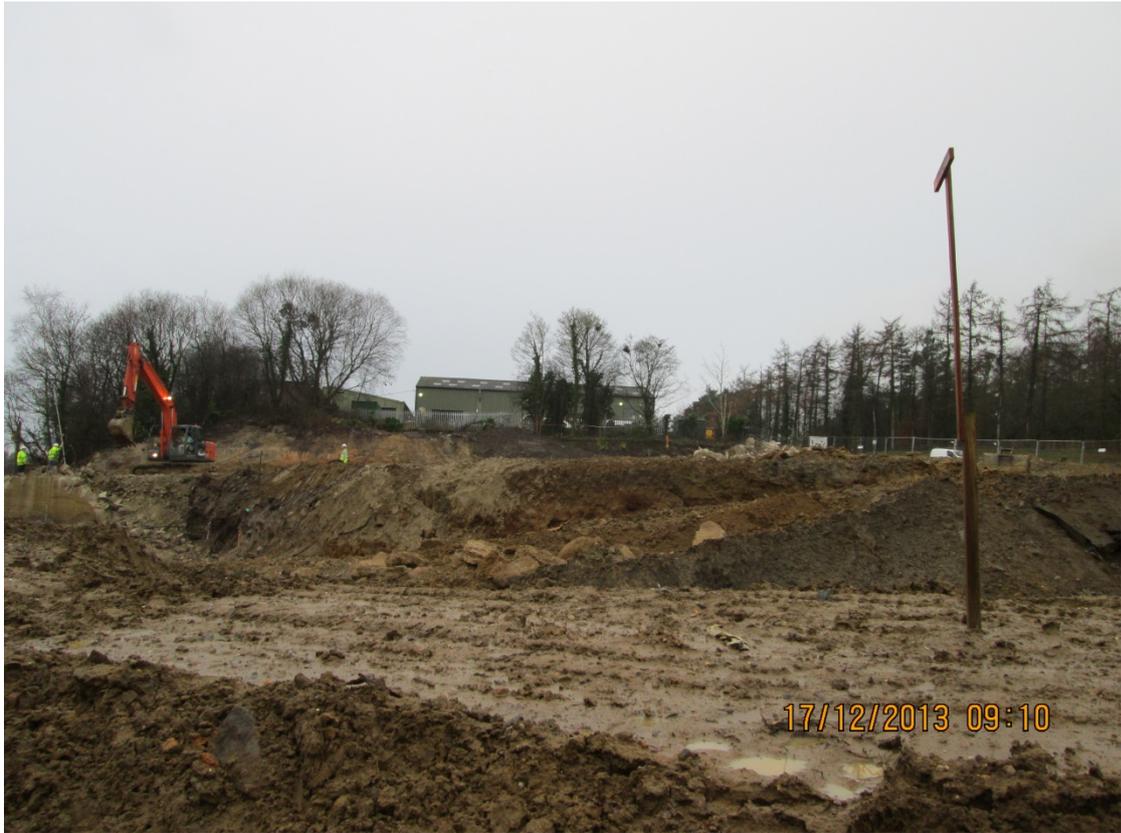
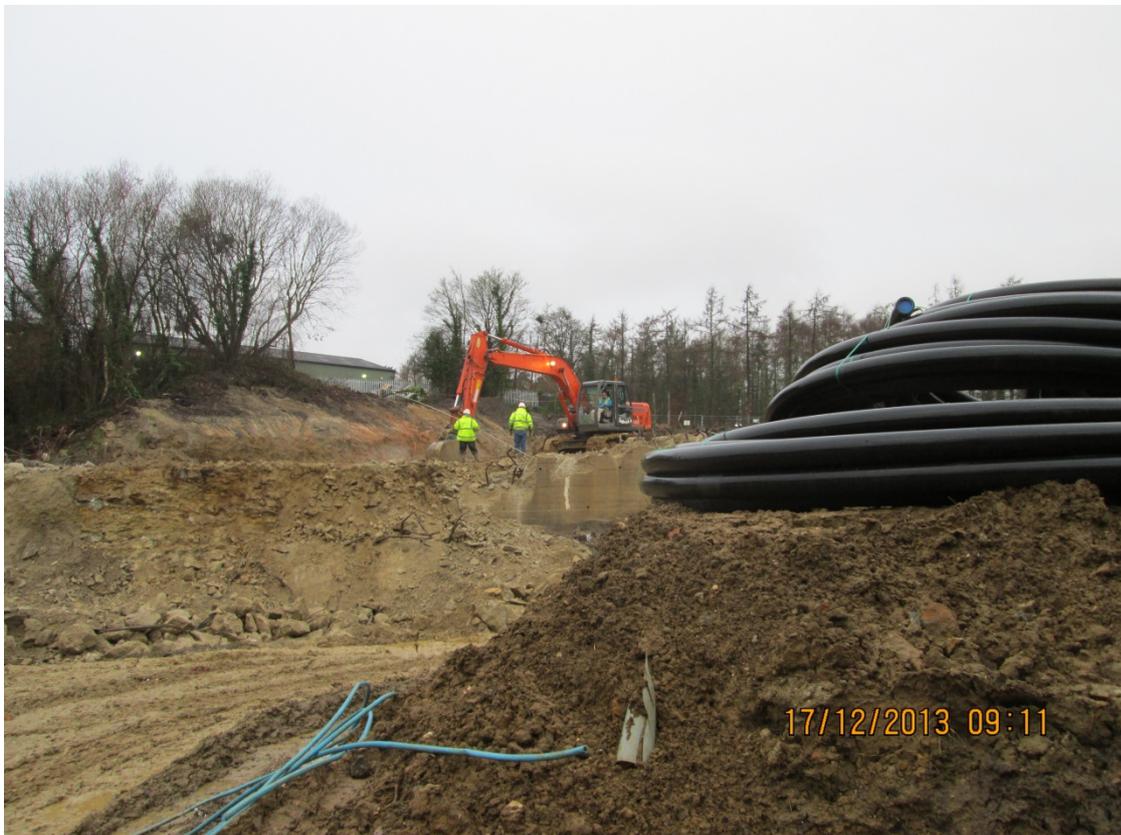
Photos taken by *Geo-Environmental Investigations Ltd* on 17.12.2013, showing that the regrading of Area 1 had not been completed by this date.

As the regrading of Area 1 had not been completed by 28<sup>th</sup> November, the removal of all contaminated material from Area 1 to the bunded contaminated stockpile in Area 5 would clearly have been a physical impossibility, and Crest Nicholson made no claim to this effect. It appears that Mr Taylor confuses matters here: *Geo-Environmental Investigations Ltd* can confirm that the construction of the bunded area built for the temporary storage of contaminated material in Area 5 was completed by 28.11.2013.

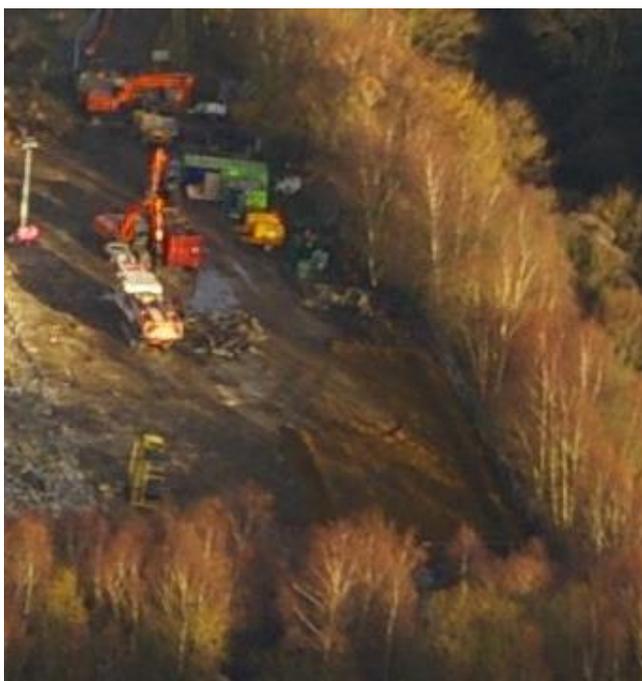
Yet again, Mr Taylor’s aerial photo is not dated, and therefore does not stand up to scrutiny in arguments about what was done when. But more to the point, Mr Taylor has misinterpreted his own aerial photograph: what he assumes to be the bund under construction is not the bund at all. The contaminated storage bund, with the top left corner left open, is actually shown in the bottom right corner of Mr Taylor’s image, near the trees (see enlarged extract below).

The same excavator shown in the *Geo-Environmental Investigations Ltd* photo on page 4 of Mr Taylor's document is also shown in the extract of the aerial photograph reproduced above, in the top right hand corner. Despite the poor resolution of the aerial photo, this view actually demonstrates why the bund could not have been visible in the *Geo-Environmental Investigations Ltd* photo taken on 05.12.2013 used by Mr Taylor.

We agree that the black plastic liner cannot be identified on Mr Taylor's aerial photograph, but that is due to the poor resolution of the photograph, and in particular the poor contrast in the bottom right hand corner. It does not prove that this liner was not in place at the time the photo was taken, as Mr Taylor alleges: a lot of other detail is not visible. Furthermore, by the date on which Mr Taylor claims to have taken this aerial photo, the bund would not have been empty; therefore it is unlikely that much of the plastic sheeting lining the base would have been visible from any vantage point.
